LOSS CONTROL ALERT – Product Warning

Manufacturer: RudedogUSA **Product:** Speed Bolt (Quickie Bolt)

Product Description: RudedogUSA- 3/4" Speed Bolt

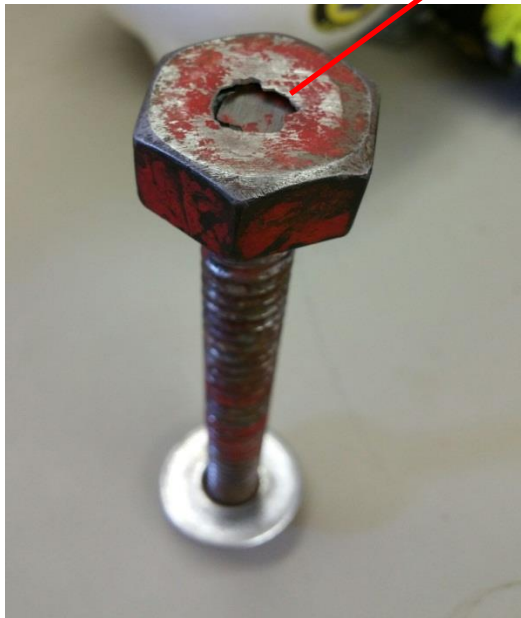
This product was being used on a SER Project to connect a steel pedestrian bridge to a beam. While the bridge was suspended by the crane, the erectors used a speedbolt on one plate and a spud on another during connecting. As shown in the picture below, the head of the Speedbolt (welded nut) broke off causing the suspended load (bridge) to become unstable temporarily. Under different circumstances, this failure could lead to rigging failure, or an unstable crane-suspended load which could strike personnel or property, or cause a crane collapse. This product appears flawed in its design, since the bolt-head is actually just an oversized nut not threaded on, and only welded on the top. The weld was then grinded down, barely leaving enough weld to keep the two connected.

This is where the head (welded nut) broke off from the rod.

Please share this alert immediately with all steel contractors and remove all **RudedogUSA "Speed Bolts"** from our projects. Ironworkers should inspect all tools before using for integrity and always select the right tool for the job.

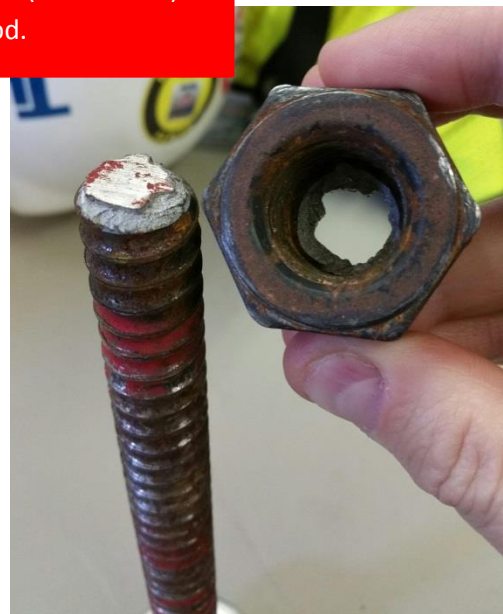
This is a 9" long by 3/4" threaded rod with a 7/8" hard nut welded on the tip.
