PERI Formwork Systems, Inc.
Formwork, Scaffolding, Engineering

Product Warning

RE: Inspection of PERI UP UAS Staircase Units

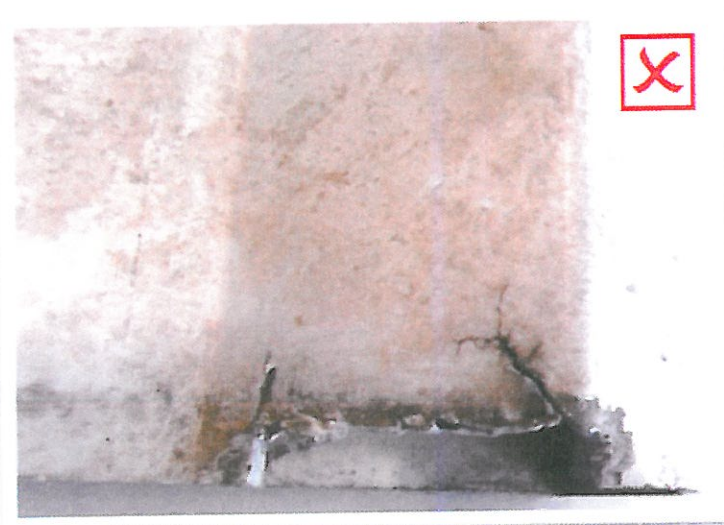
Criteria 1:

1. Cracks in material: Not acceptable
2. Material must be scrapped
3. No repair
